An Overturned 19,000-Ton Caisson Successfully Salvaged

Pier construction of Mid-Hudson Bridge delayed a year by remarkable accident in sinking largest open caissons ever used—Main span shortened to suit shift in pier locations

By GLENN B. WOODRUFF
Consulting Engineer, New York City

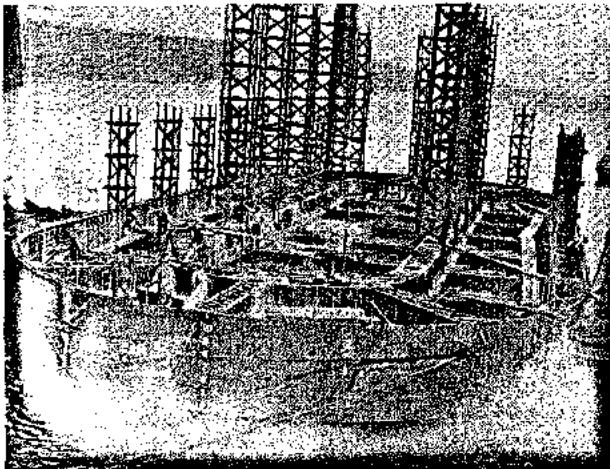
Fig. 1—Cutting edge section before sinking

This portion was built up as a core and formed the support for the upper concrete section.

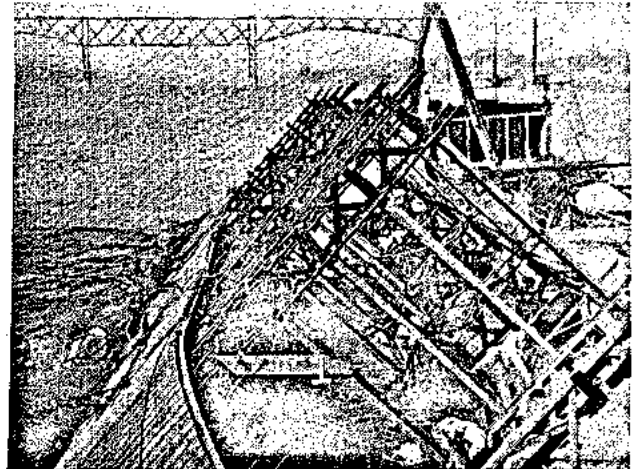
Fig. 2—East caisson after tipping

The entire movement through a 42-deg. arc occurred in about 1 min. One edge dropped 29 ft. The other rose 11 ft.

On the night shift of July 25-26 the contractor removed 164 cu.yd. of material from the center pockets. On the following night shift, July 26-27, he excavated 254 cu.yd. of material from the center and east side pockets. At 4:30 a.m. on July 27 the caisson listed to an angle of $42\frac{1}{2}$ deg. from the vertical (Fig. 5); from the estimate of a foreman on the caisson at the time the entire movement occurred in about a minute. The east edge dropped about 29 ft., the west edge rose 11 ft., and the center of gravity dropped 9 ft. After motion started it continued until resistance under the east edge and the building up of a bank or earth wave at the east side overcame the momentum.

It is the opinion of the engineers, the author included, that the sole cause of the accident was that the weakened walls of clay, which on the east side served as supports, were unable to withstand the comparatively high pressure of 2 tons per sq.ft. and failed. The lateral support of the material under the center and east walls had been removed, and this material had been also subjected to the softening effect of water from the sides. The

excavation had created, in effect, a ditch into which the caisson overturned.

Steps were at once taken to prevent further overturning. Two lighters were placed along the east edge of the caisson with attachments to the steel frame. Two 150-ton crib anchors were sunk 600 ft. west of the caisson and connected by lines to the west top. pontoons with a total capacity of 300 tons were attached to the east side of the caisson but were not in working condition until Aug. 13. About 400 cu.yd. of gravel was banked on the river bottom along the east side of the caisson.

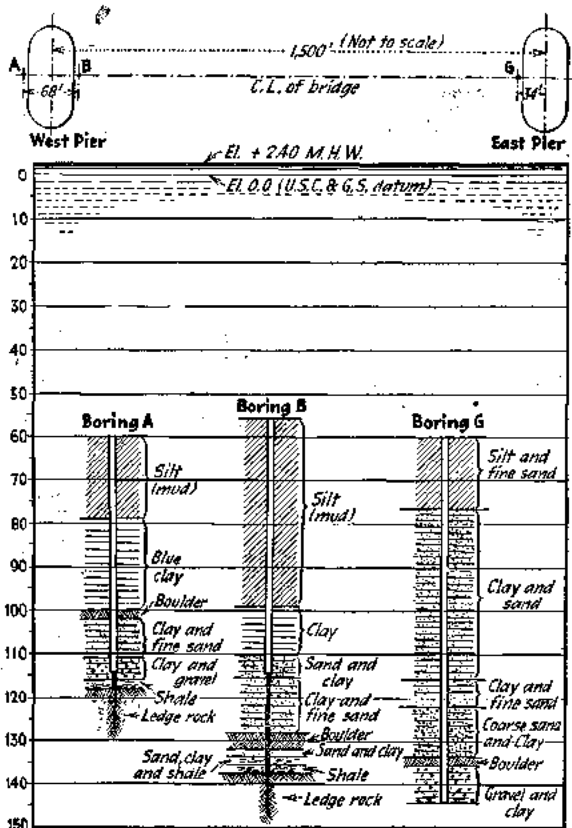
Fig. 3—Typical boring results

Deep soft ground led to use of open caissons for pier foundations of Mid-Hudson Bridge.

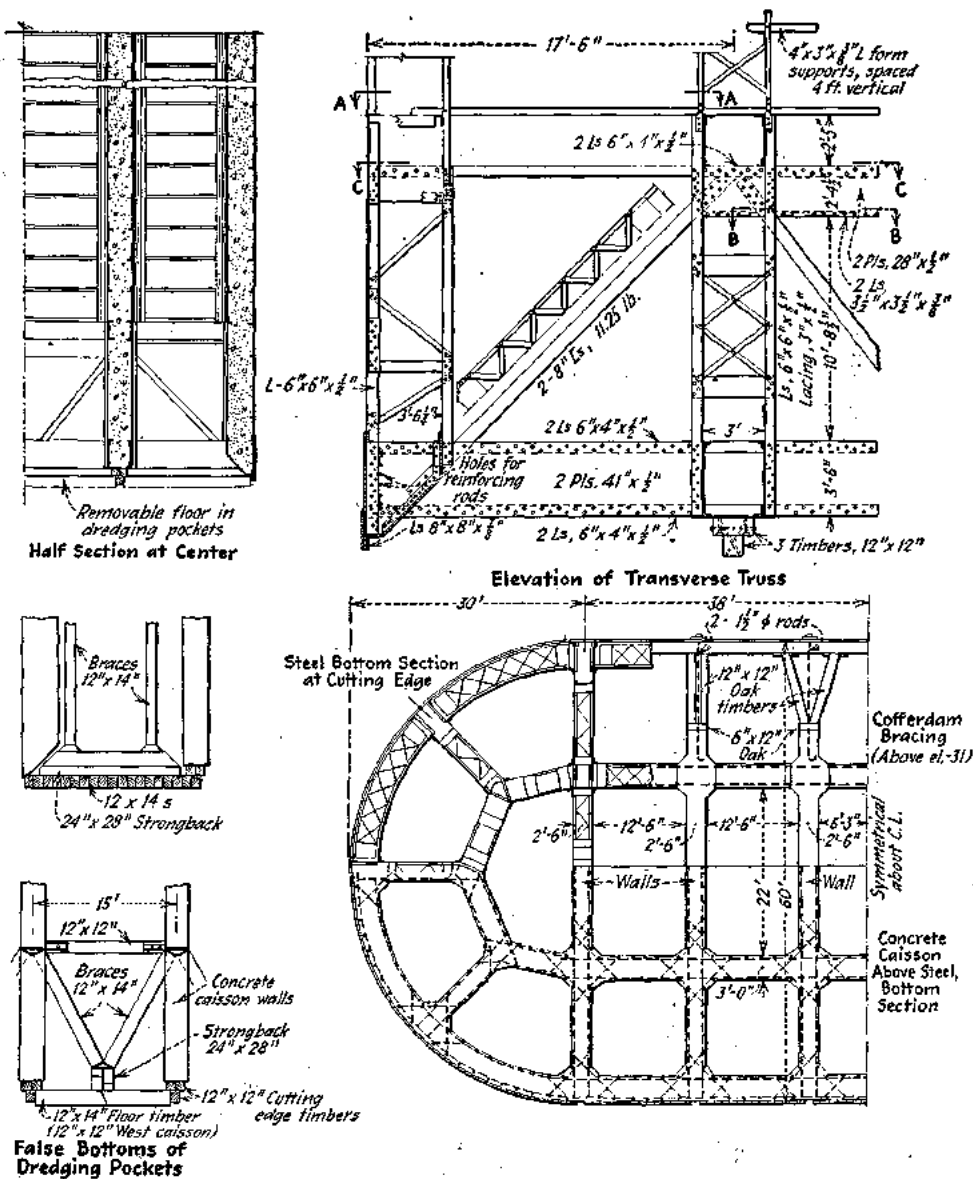
Fig. 4—Lower 20-ft. section of caissons

This section consisted of a concrete-filled steel shell braced by a heavy structural-steel frame; remainder of height is reinforced concrete. Collapsible false bottoms used in floating and sinking the caissons gave much trouble in removing.

Where the riverbed consists of a fairly stiff material, as was the case at the east caisson, the false bottoms should be constructed with more braces. In this way the shorter spans would permit lighter material for the floor.

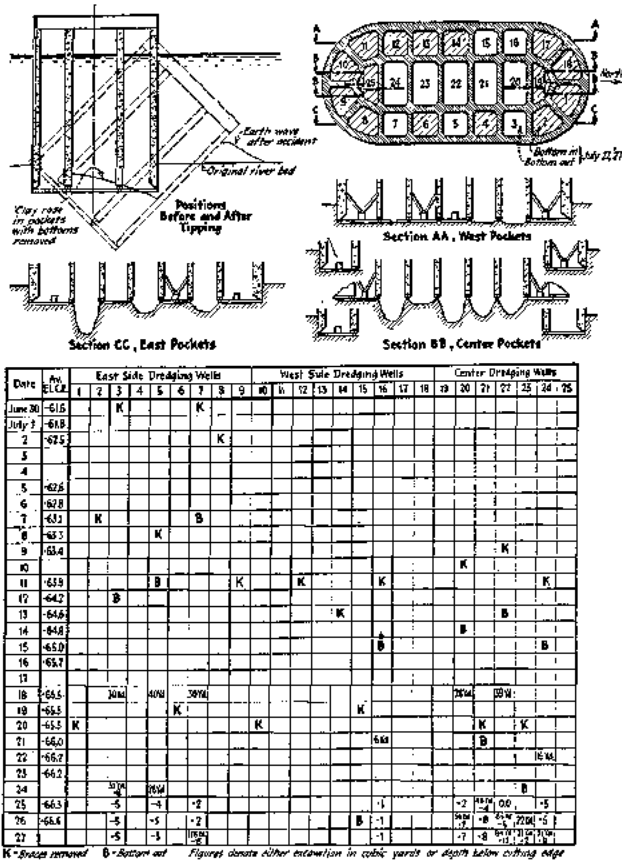
Fig. 5—Condition of bottoms and of pocket excavation before tilting of east caisson and resulting position of structure

By June 30 the concrete walls had been built up to 72 ft. above the cutting edge, which was then 61.6 ft. down. On this date the braces were removed from pockets 1, 3 and 7 by exploding 3 lb. of dynamite at the foot of the diagonal braces. Contrary to expectation, the bottoms failed to give way when the braces were removed, and their removal proved difficult. They were slowly removed by first ramming them with a heavy concrete pile until the timbers were broken up and then chewing them out with a dredge bucket. The progress of the false-bottom removal is recorded in Fig. 5, which also shows, by dates, the material excavated from the various pockets. Prior to July 26 very little excavation had been done, except that incidental to removing the bottoms and cleaning out the material that had come up in the pockets above the cutting edge. All pockets were filled with water to river level.

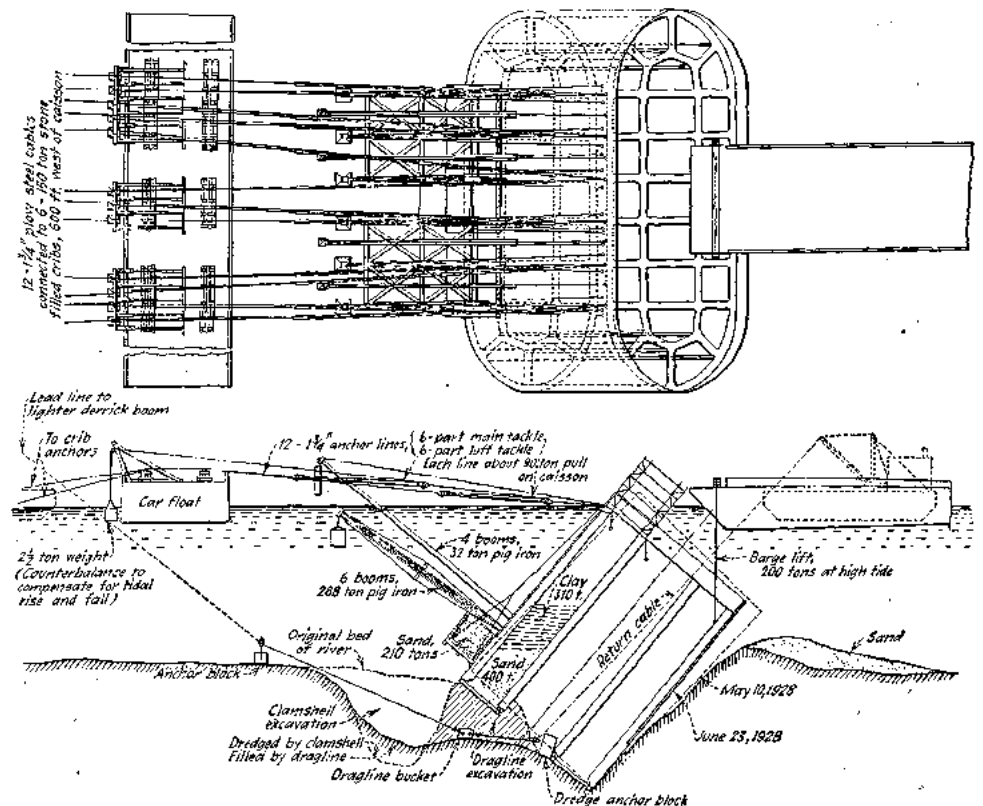
Fig. 6—To right the caisson, weighted booms and pulling tackles anchored to sunken cribs were rigged to apply 1,500 tons pull to the west at the top edge, while the soil was being dug away under the west half of the base

The various pulls applied to the caisson to produce this torque are shown diagrammatically in the sketch, Fig. 6. Their amounts and moments about the east cutting edge were as follows:

The lines to the west produced the greatest force toward righting the caisson. As first placed each line consisted of a 1½-in. plow steel rope attached to rockfilled cribs placed about 600 ft. west of the caisson and attached to the caisson by a six-part tackle. To secure a greater leverage, a carfloat was placed at the west of the caisson and the lines carried over the float. As these lines were first rigged in the fall of 1927, they had to be tightened at low tide, and the full pull occurred only at high tide. Later, to give a steady pull regardless of the tide, the free end of the main tackle was connected to a six-part luff tackle, the free end of which passed over a pulley and carried a 2½-ton weight.

The lines over the carfloat were so rigged as to keep the forces in play at all stages of the tide and were of prime value and effectiveness, without adding weight to the caisson.
