An Overturned 19,000-Ton Caisson Successfully Salvaged

Pier construction of Mid-Hudson Bridge delayed a year by remarkable accident in sinking largest open caissons ever used—Main span shortened to suit shift in pier locations

By GLENN B. WOODRUFF
Consulting Engineer, New York City

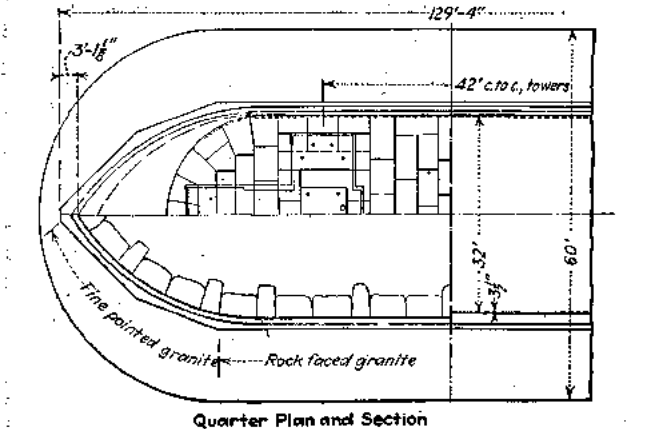
Fig. 7—Stone-faced concrete piers built on the caisson substructures within removable cofferdam inclosure
